November

# approach

NAVAER 00-75-510

THE NAVAL AVIATION SAFETY REVIEW

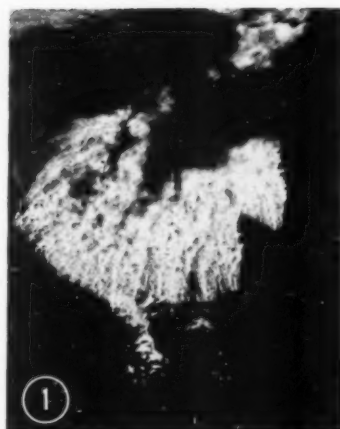
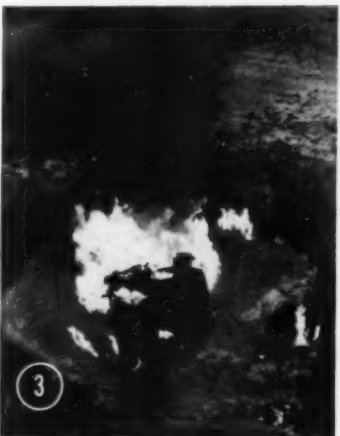
Photo (2) about five seconds later the air flow from the helicopter is taking effect. (Note the cockpit area.)

Photo (3) ten seconds have elapsed—crash crew personnel walk into the FJ-4, up to the cockpit simulating rescue of a pilot. No foam or fire retardant was used on this fire.

Several days ago we held some fire fighting drills in our burn area to determine the practical use of a helicopter in fighting a fire. The following items were utilized:

It was found that the best results from use of a helicopter in this type of a fire were as follows:

The HRS helicopter was operating at approximately 7000 lbs. at the time of this drill. The wind was 8-10 knots and specific humidity was .015. I hope this information will help some of the people yet undecided as to the use of HRS helicopters as fire fighters and a good tool in their crash crew work.

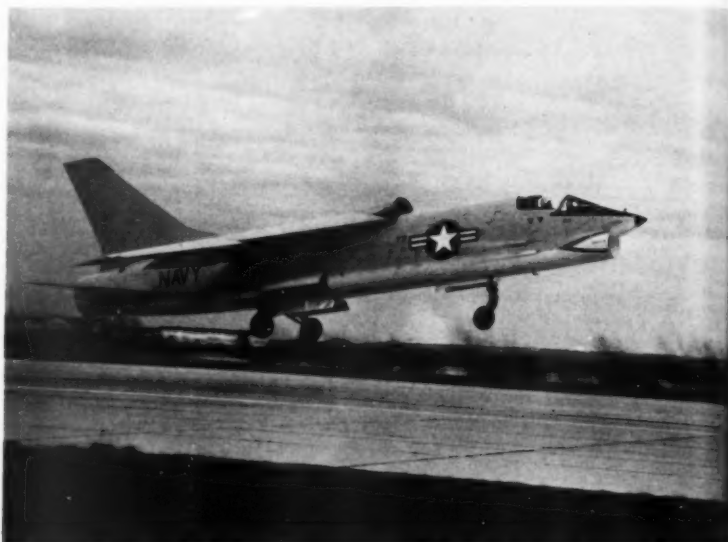
Airborne successfully, following an earlier aborted takeoff, the F8U pilot was unaware of a sizzling hot wheel assembly which was soon to explode.

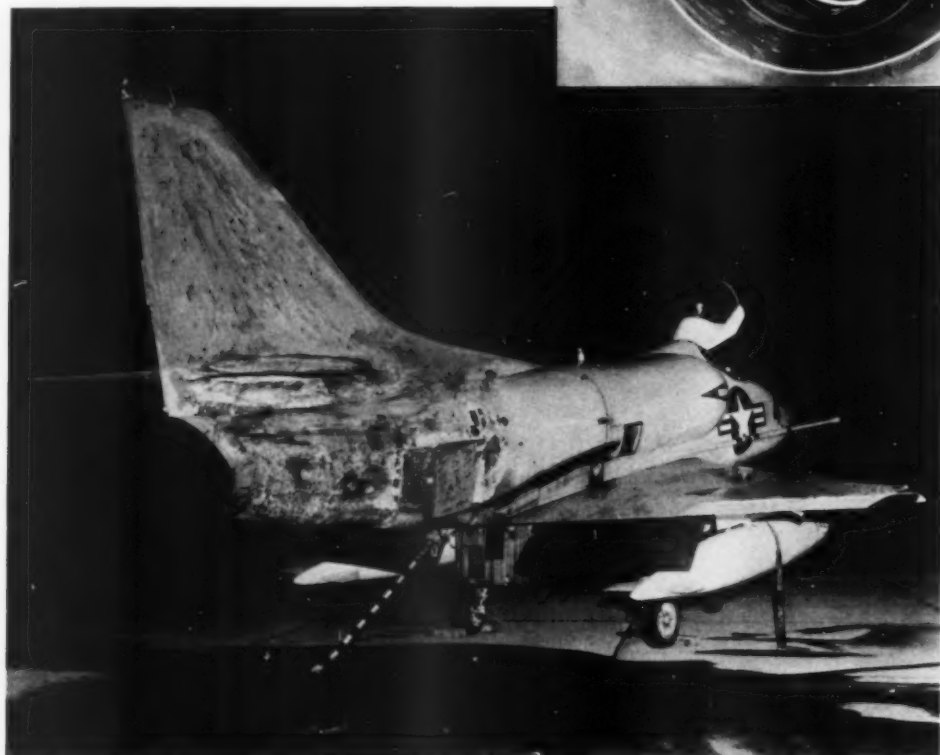
The tailpipe had become separated from the exhaust duct assembly and moved rearward six inches and to the left three inches (see photos left) permitting jet exhaust blast to escape and cause heat damage to aft fuselage components.

In this case too, the Marmon clamp securing the tailpipe to the exhaust cone was improperly installed, not torqued, and not lock-wired. The loose clamp allowed heat to escape upon application of high power.

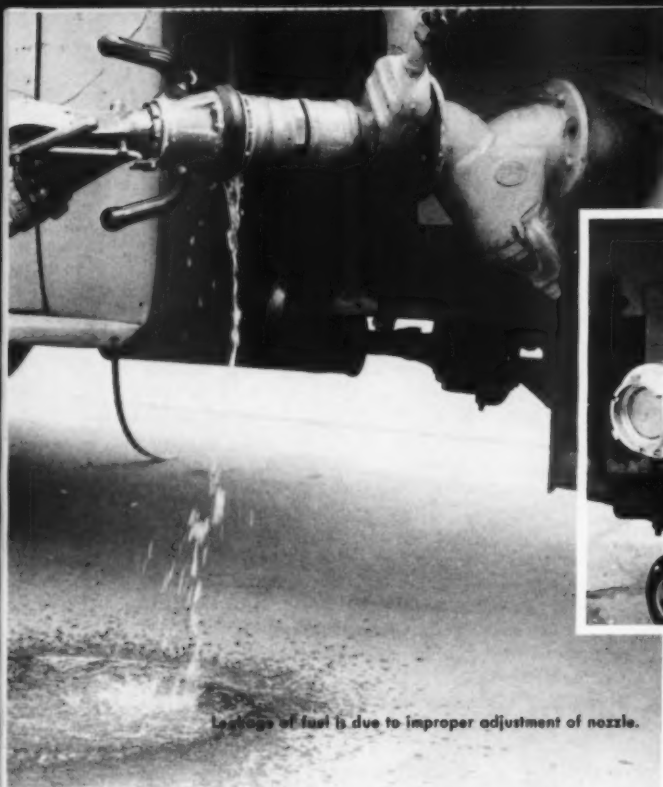
Leakage of fuel is due to improper adjustment of nozzle.

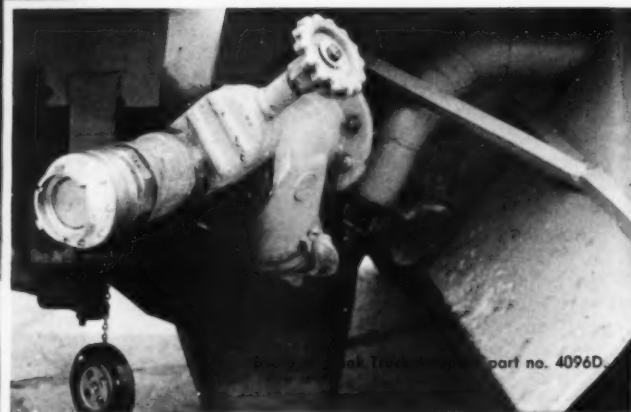
Inspect for proper alignment, handle position, and opening handle, and general condition.

## FUEL NOZZLE INSPECTION TECHNIQUE

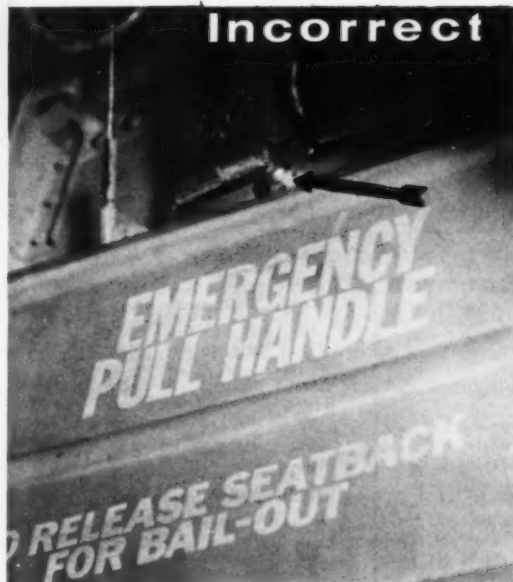
**Incorrect**

## Incorrect Method of Installing Shoulder Harness to Radar Operator's Seat in S2F Aircraft

Investigation of complaints by S2F radar operators that their shoulder harness would not return after being pulled out from the locked position, revealed the following:
